Removing the A/C Plenum in Your Late-model Westfalia

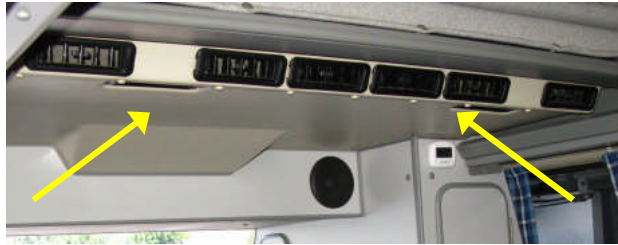
It is the large, plastic-molded ducting installed underneath the upper bed, above the rear seat in all 1986-1991 Vanagon Westfalia campers and pop-top "weekenders". It is referred to as a *vent channel* in the Bentley Service Manual.

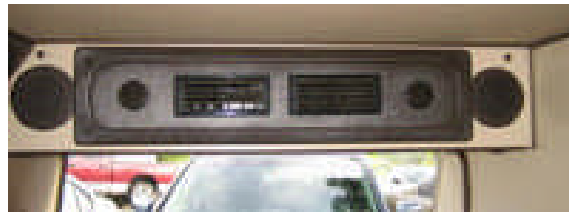
Theory 2: There is another theory floating around that the plenum was installed to create back pressure in order to increase the cooling efficiency of the evaporator. True or not only Volkswagen knows, but I, personally, tend to doubt this theory being the *main reason* behind adding the plenum. Up through the 1985 model year, Westfalias had no plenums and the vents sat center in the cabinet:

Therefore, VW/Westfalia did not decide to install a plenum just to increase evaporator efficiency. This was a complete redesign of the blower/vent system, and in doing so required Westfalia to make two different overhead cabinets (as you can see with the above 1985, what would have been a cabinet door in a non-A/C camper was simply filled in with a vent plate). Raising the main vent and adding a vent channel to deliver air *over* the rear passengers indicates, to me, that the main reason for the plenum stands with Theory 1.

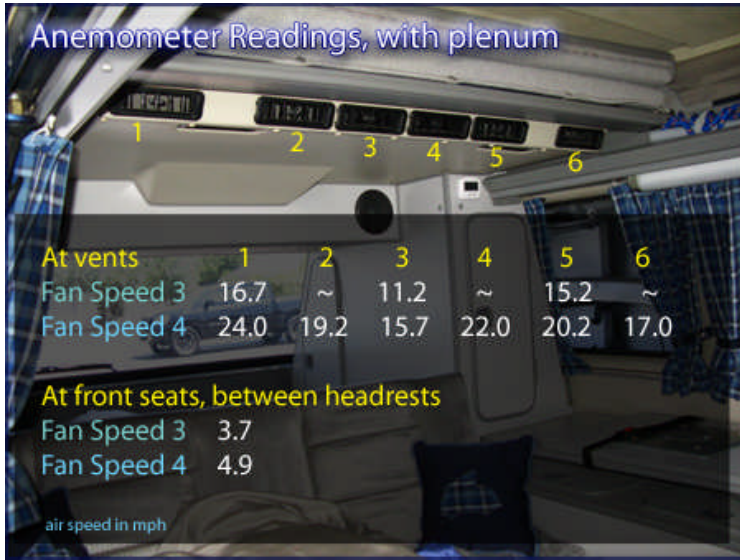
Airflow readings (in mph):

The airflow readings at the plenum vents vary due to the plenum's internal baffles (they also double as mounting brackets). As you can see, without the plenum, the airflow at the front seats nearly doubles! I should also note that the underside plenum vents (the two aimed at the floor) in my 1990 Westfalia were blocked off; don't know if it was factory, but it is apparent that either the factory or a previous owner wanted more air to be diverted through the upper vents. Therefore, those plenums with the two underside vents open will have slightly lower plenum vent airflow readings.

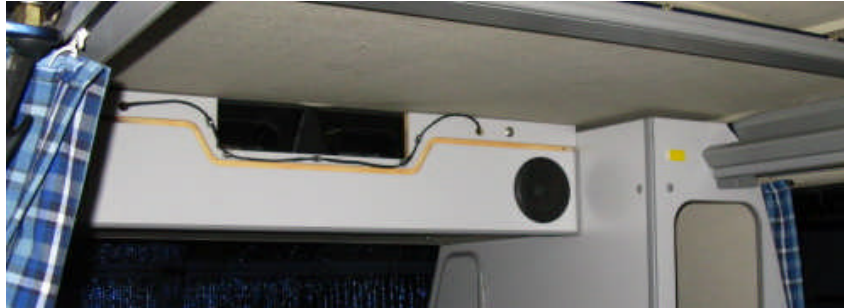
- Small holes in the ceiling
- A routed groove in the cabinet where the plenum fits into
- Two nickel-sized holes in the cabinet (what the speaker wires are routed through)
- Five metal wire clips on the cabinet (mounted with adhesive)
- Speaker wires encased in electrical tape (or wire loom)
- 13-3/16" x 3-5/16" vent hole
- Possible black marks on the ceiling if your blower fan has regurgitated the evaporator's foam filter guts and whatnot (Mr. Clean Magic Erasers *should* clean most of it off)

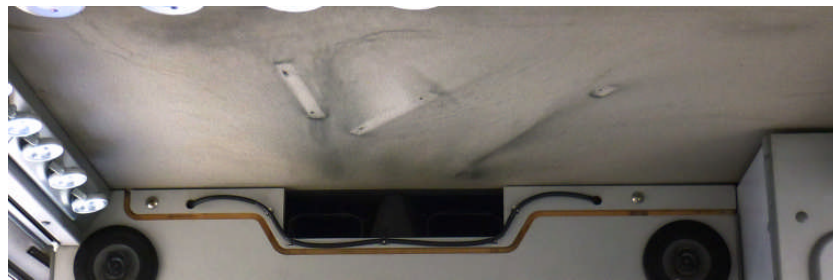
The gap above the closet is typical of even non-A/C Westfalias
